Subject: Technical Memorandum, Characterization Soil Sample Collection at the Former  
Big Polovina Hill Debris Pile

**Photo Log**  
**October 15, 2005 Characterization Sampling at the Big Polovina Hill Debris Pile**  
**St. Paul Island, Alaska**

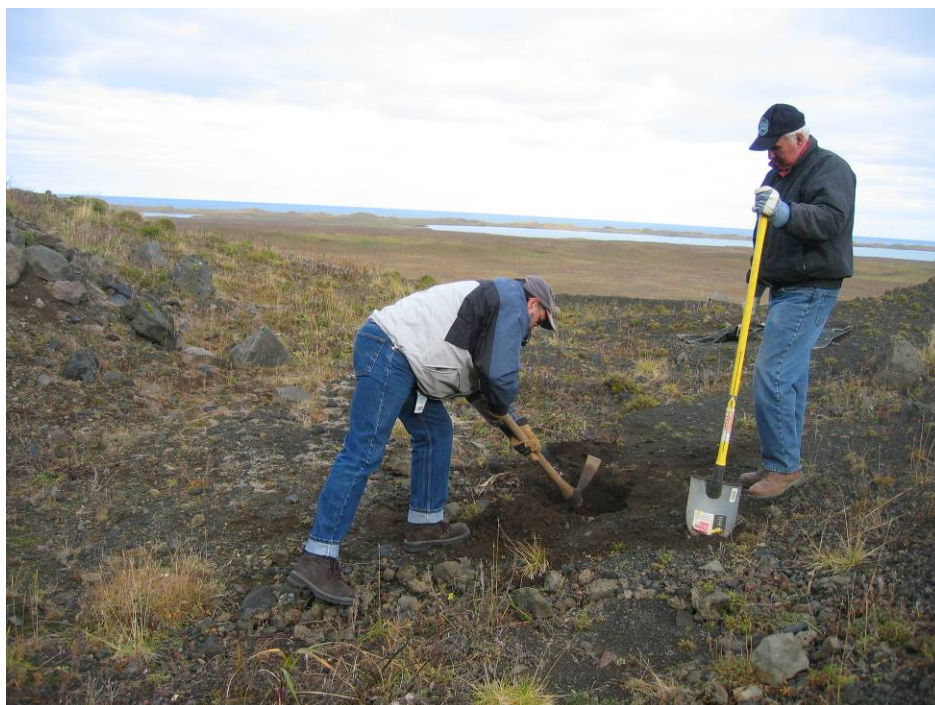
**Photograph 1.** NOAA employees digging to 18 inches deep at sample location SP44-CH001 at the Big Polovina Hill Debris Pile site, facing north. October 15, 2005.

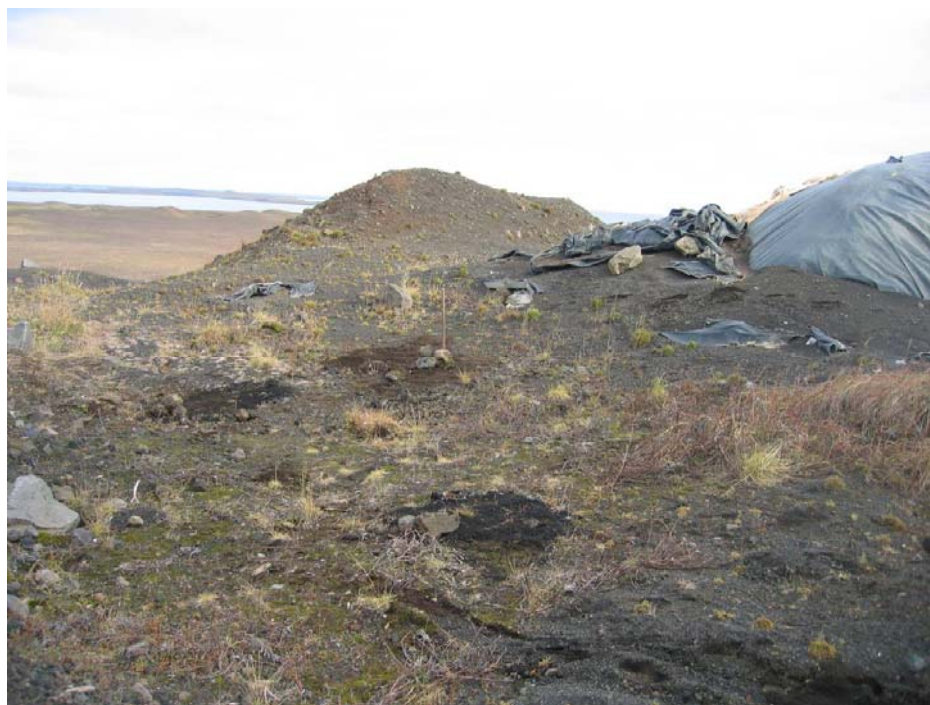
**Photograph 2.** Disturbed soil showing locations of the three characterization samples collected by NOAA on October 15, 2005. Facing Northeast.
